INSPECTION REPORT Nr GPSS-18368-20210911

PROJECT: N/A	Ref: JP-GPSS-442
J-PECO Client: GPSS	P/o nr: GPSS-18368 (client to J-PECO)
Manufacturer: Zhejiang XXX Stainless Steel Co.,Limited	P/o nr: N/A (J-PECO to Manufacturer)
Inspection requested by: GPSS

As per request of CLIENT, the undersigned inspector Jiang JianKui from **Anhui Jipeng Project Supervision and Consulting Co., Ltd.** China performed final inspection for the pipes at **Zhejiang XXX Stainless Steel Co., Limited.** (hereinafter referred to as *Supplier*) on 11th, Sep, 2021.

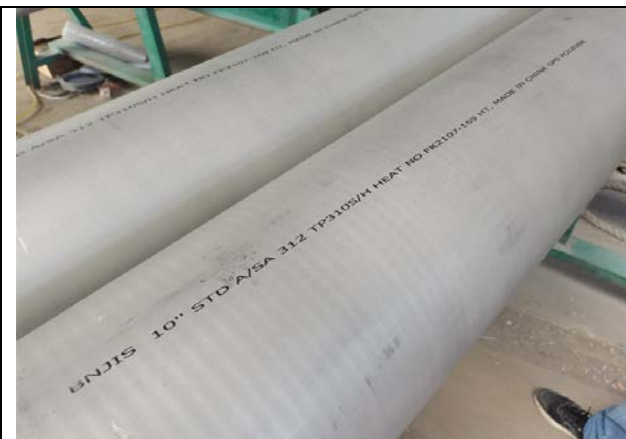
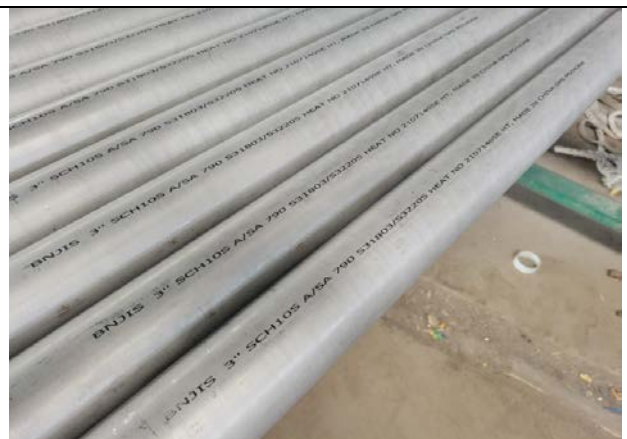
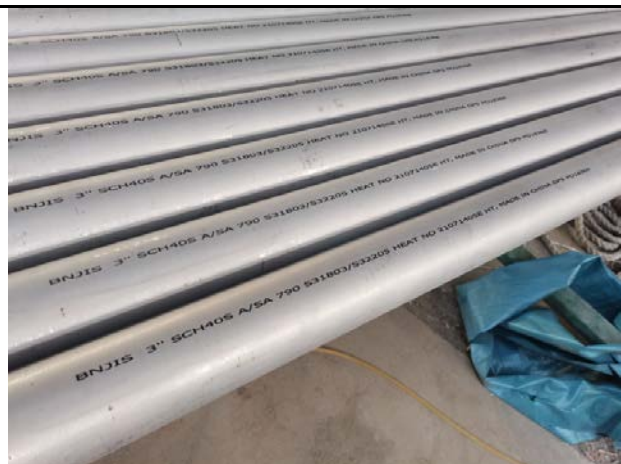
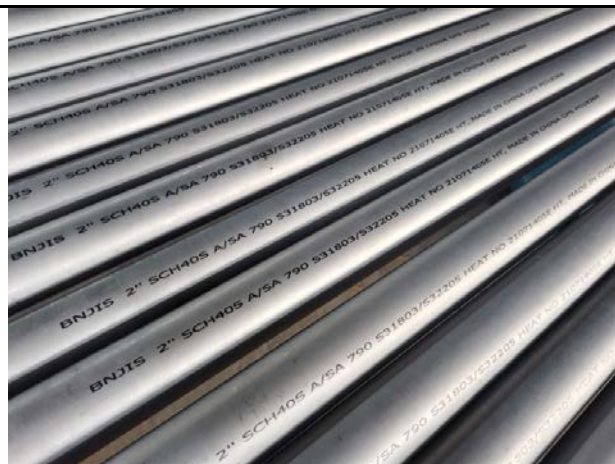
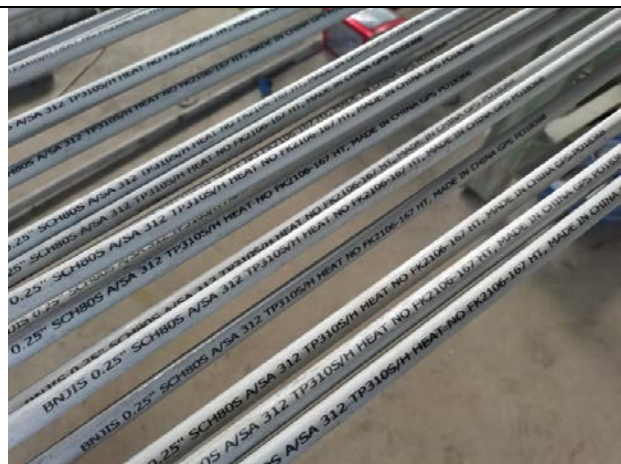
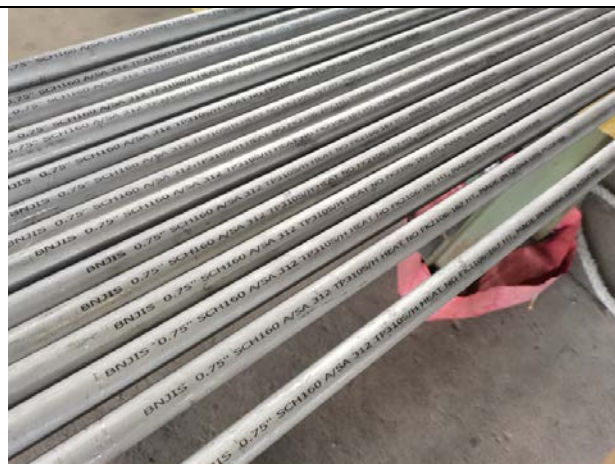
2.1 J-PECO inspector checked the pipes markings according to order requirement, the result was acceptable. The sample was as follows:

Marking check

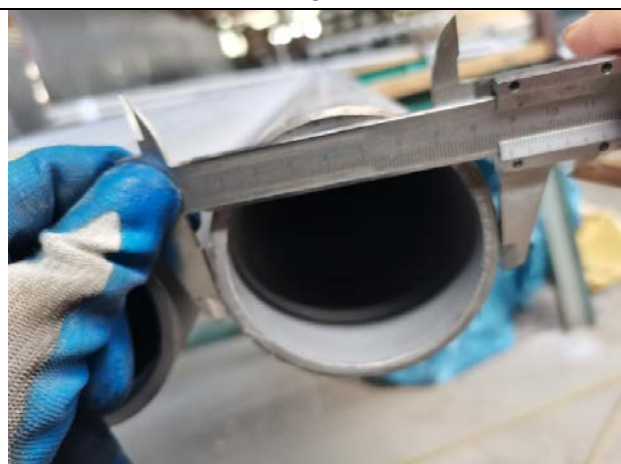
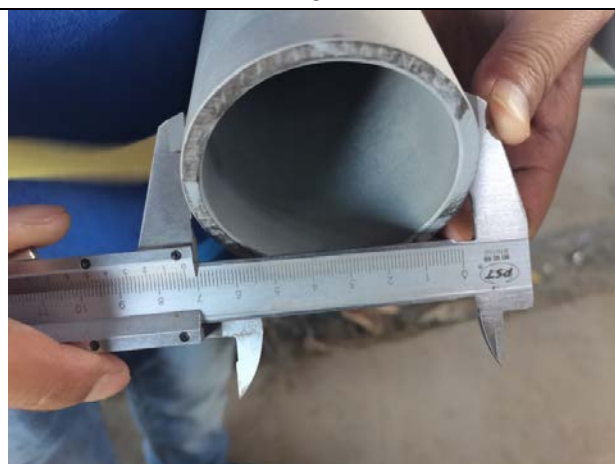
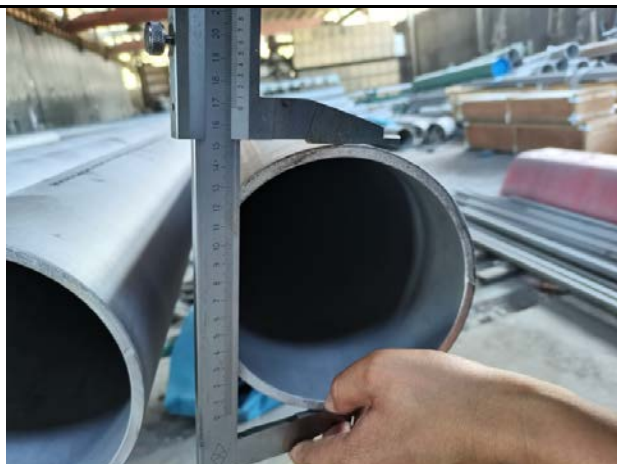
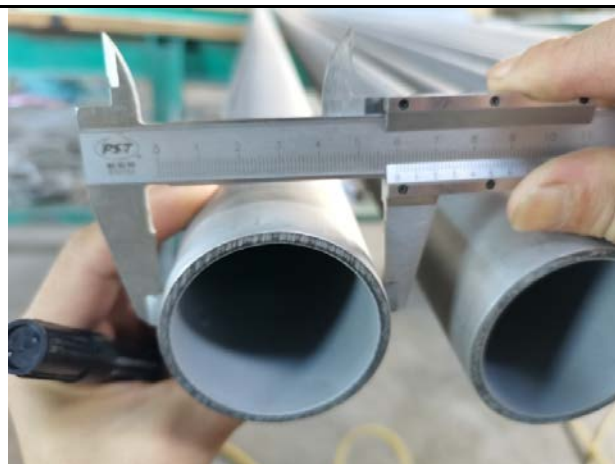
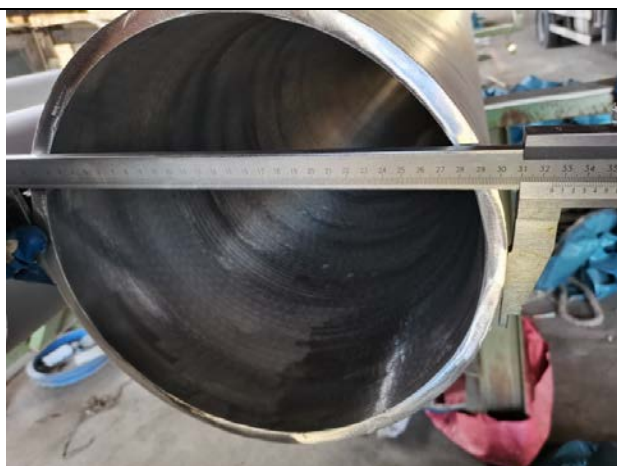
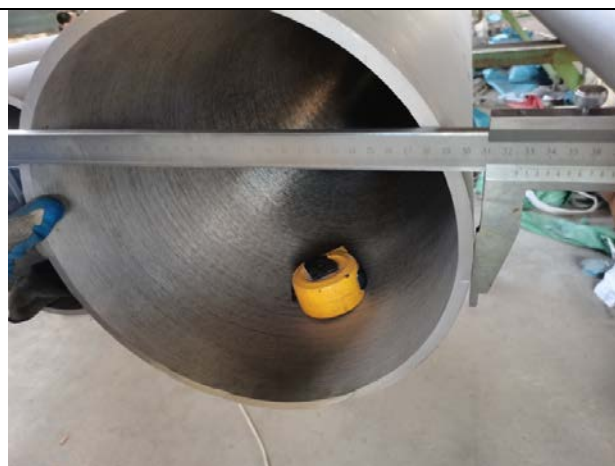
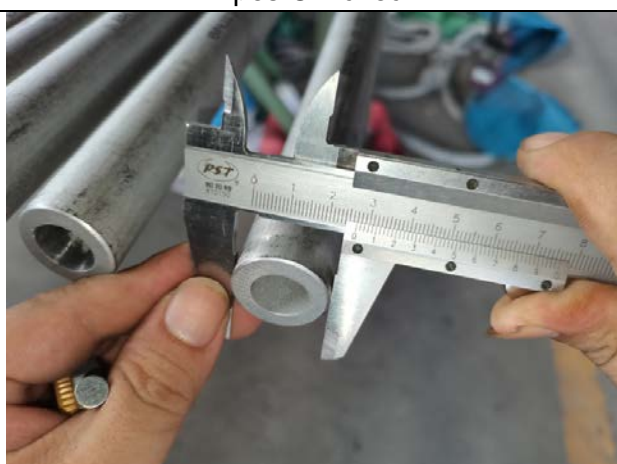
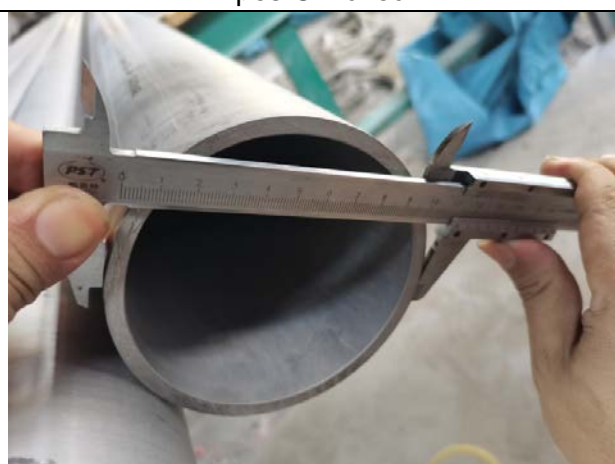
2.3 J-PECO inspector witnessed dimension check of the pipes by sampling of 30%. The outer diameter, wall thickness and length met the requirements of standards and regulations. Details inspection data see the following annex-1.

Pipes OD check

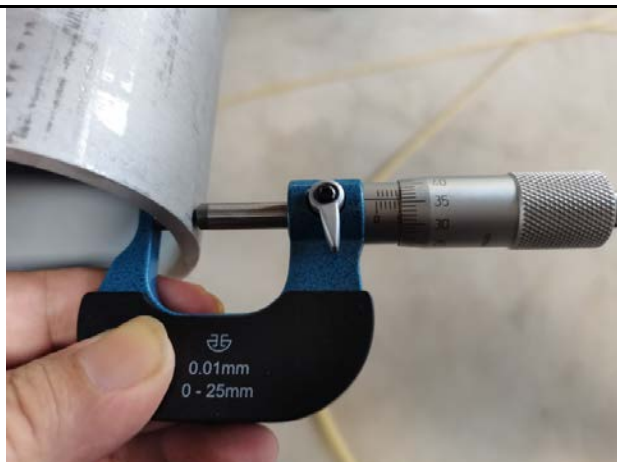
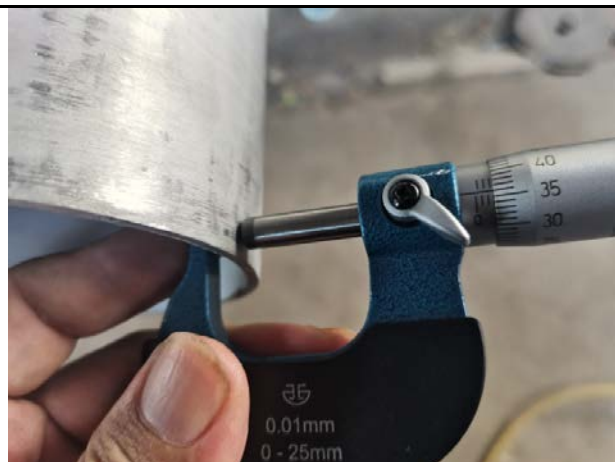
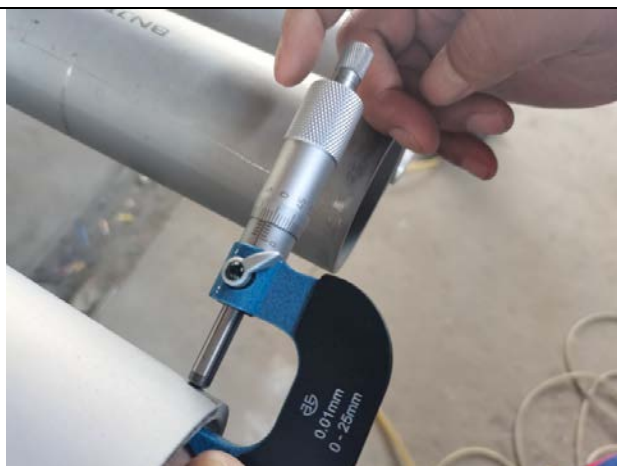
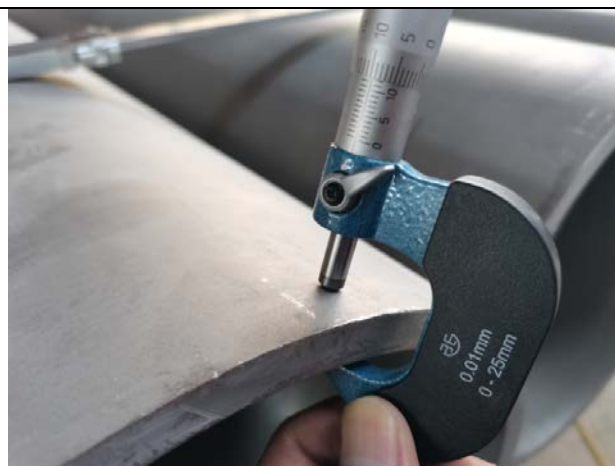
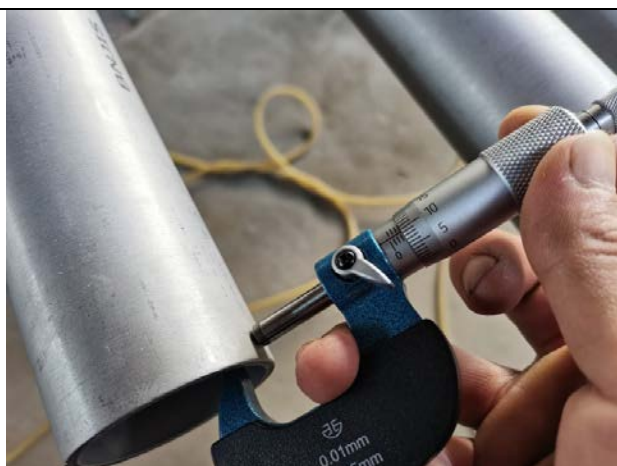
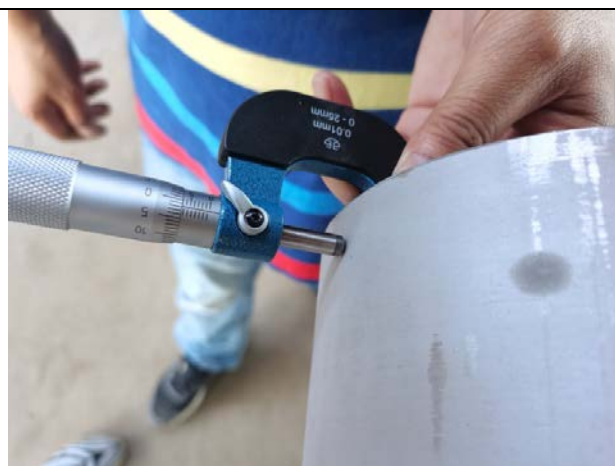
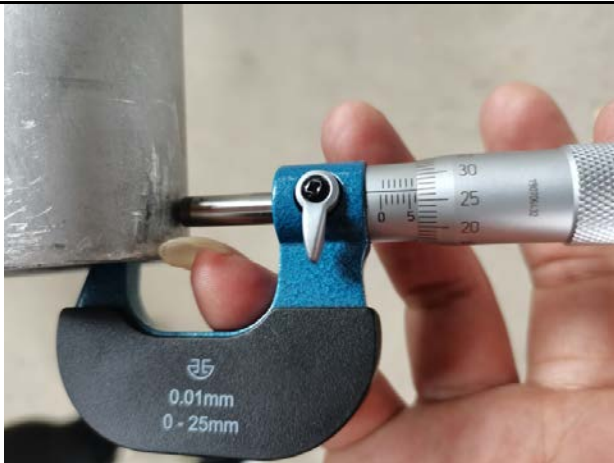
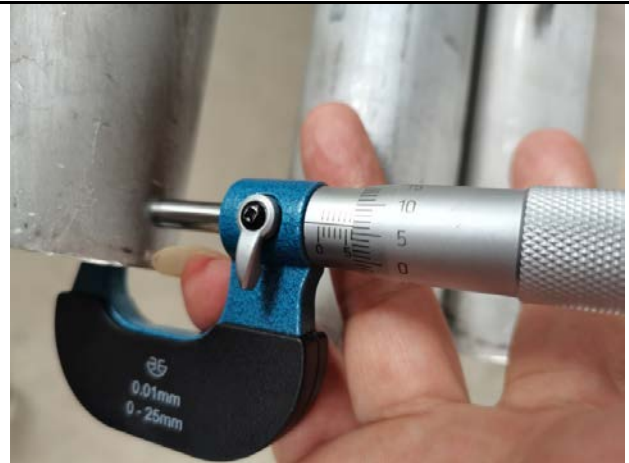
Note: the thickness of item 3 should be 4.45~6.1, but the actual value was 6.0~6.3 which was out of tolerance, so the result was unacceptable. Some lengths of items exceed the required value which needs the confirmation by the client. Detailed data please see the following annex-1.

Pipes thickness check

**Pipes thickness check**

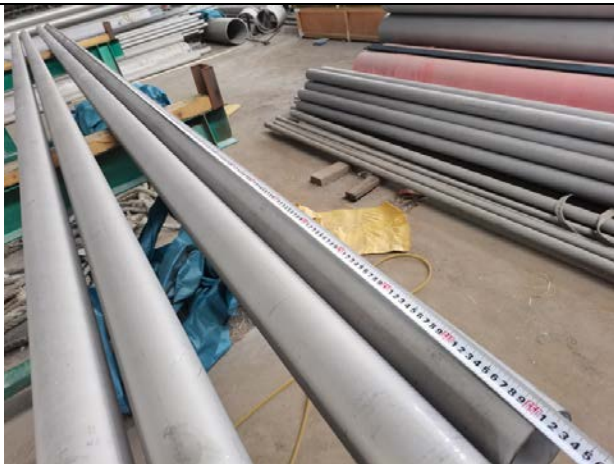
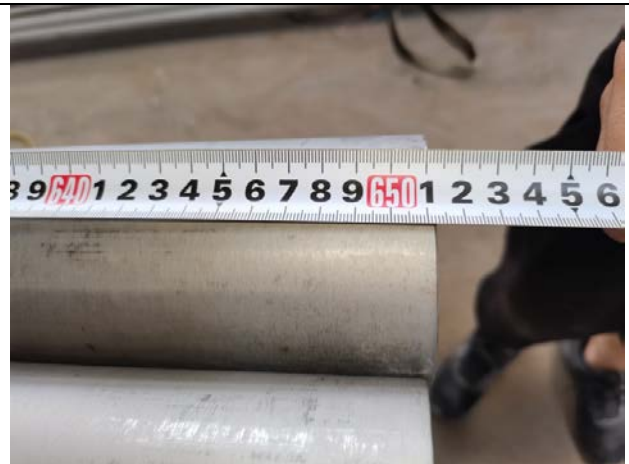
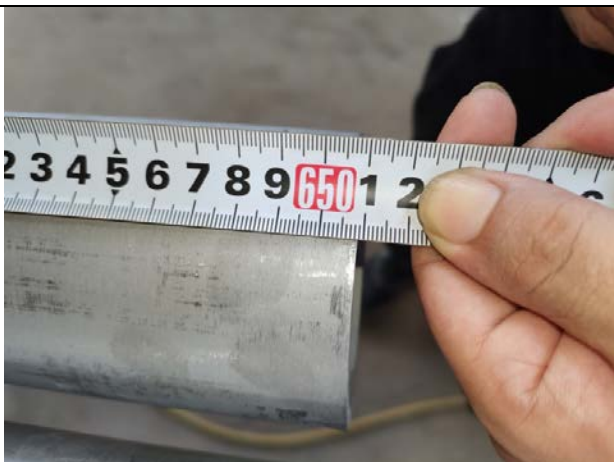
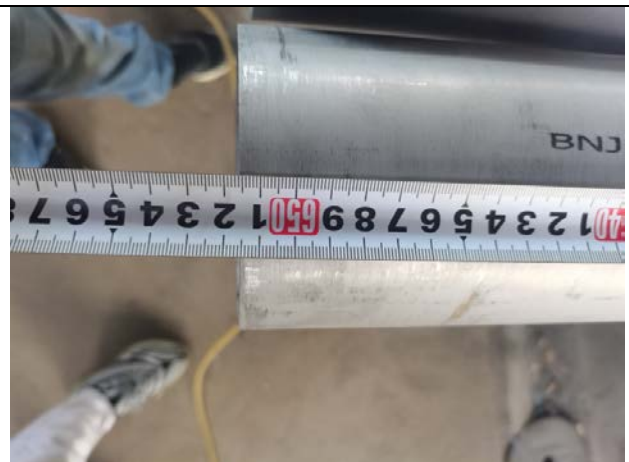
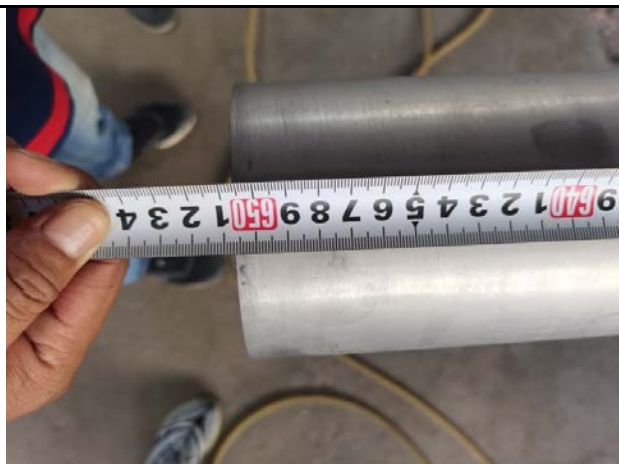
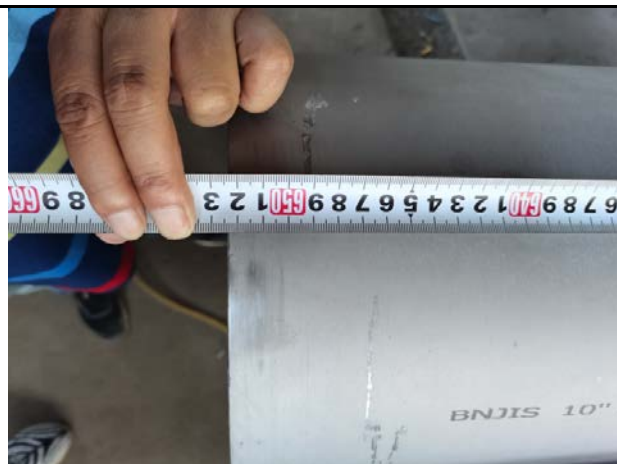
**Length measurement**

Length measurement

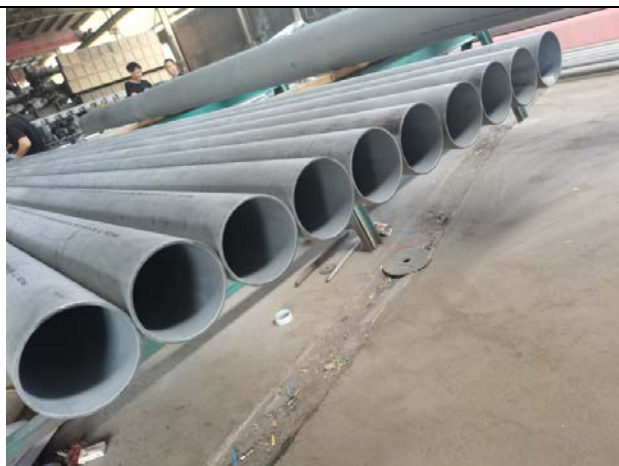
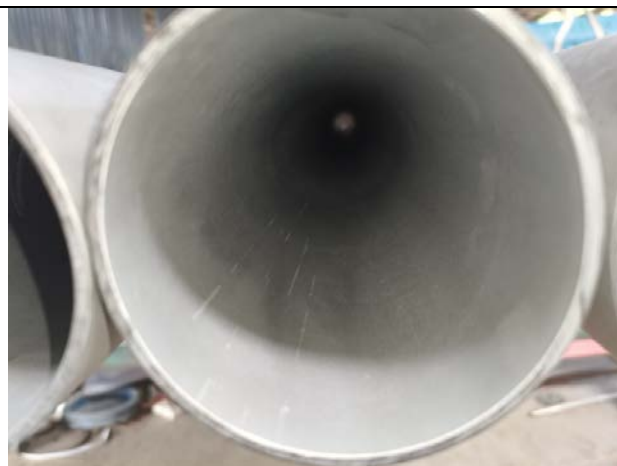
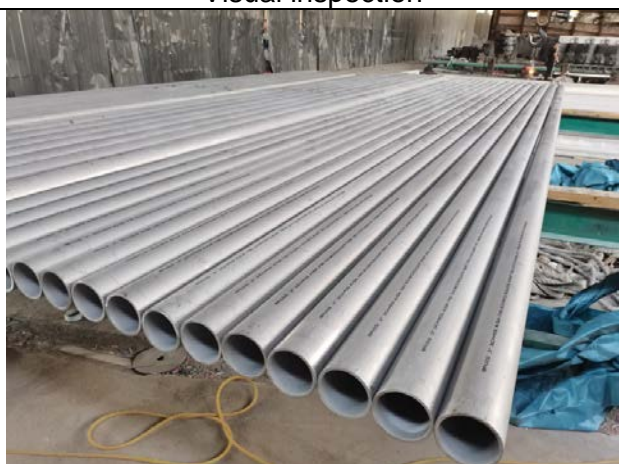
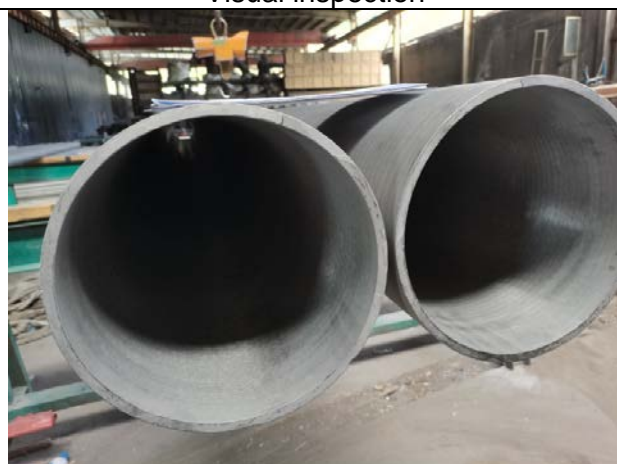
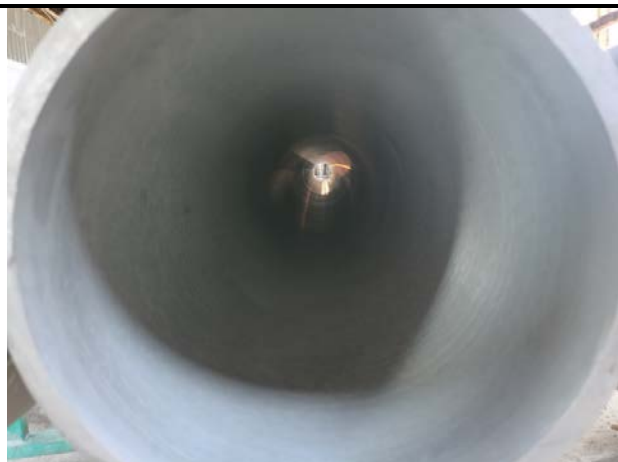
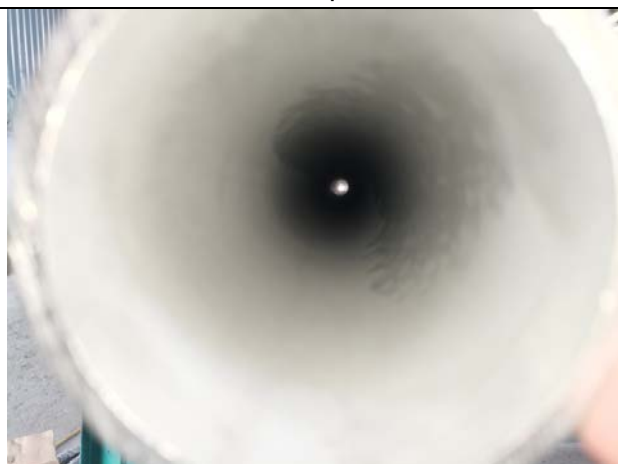
2.2 J-PECO inspector witnessed 30% visual inspection on the pipes. No stains or scuff marks were found. The result was acceptable.

Visual inspection

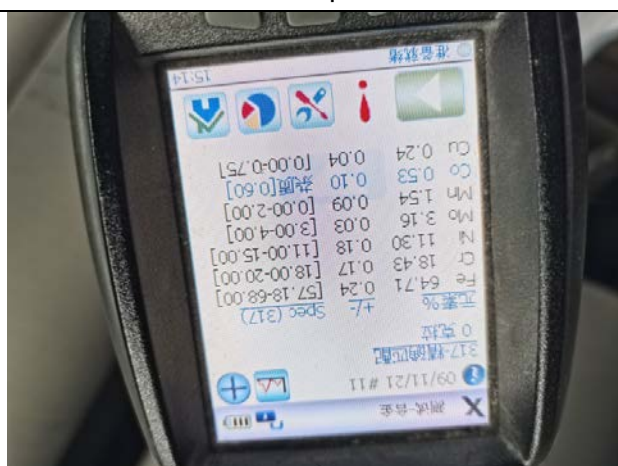
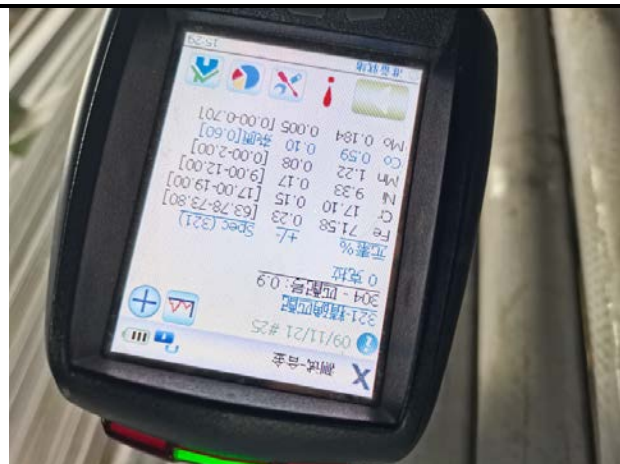
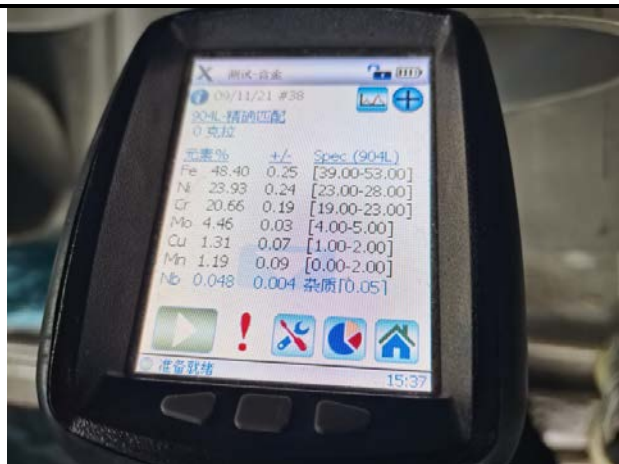
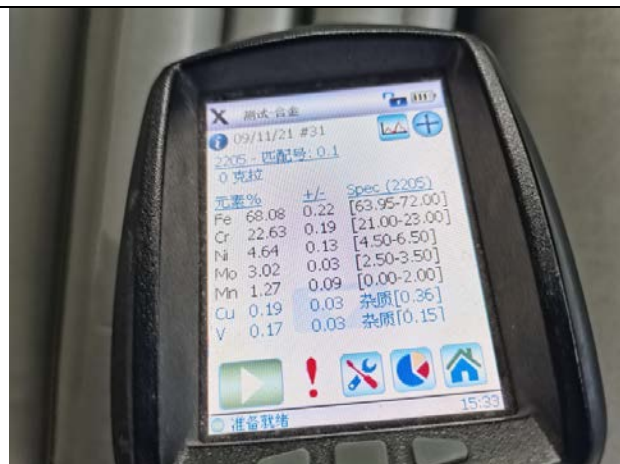
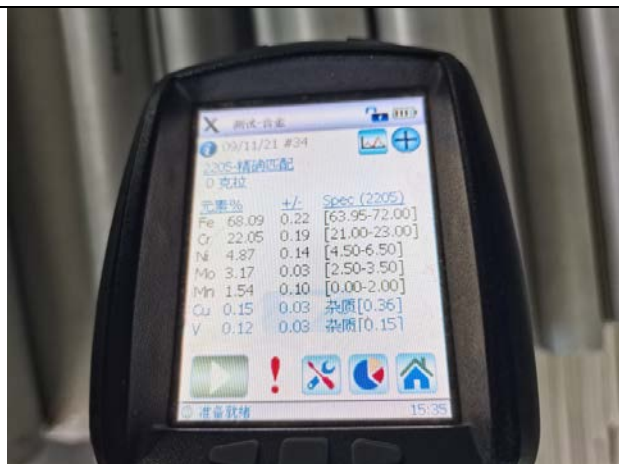
2.4 J-PECO inspector witnessed PMI of the pipes by sampling of 30%. Test result only showed composition of metallic elements, inspection result met the requirement of the standard and the order. Details inspection data see the following annex-2.

PMI test

PMI test result
